METALS HANDBOOK

VOL. 9
FRACTOGRAPHY AND ATLAS OF FRACTOGRAPHY

8th EDITION

Fractography and Atlas of Fractographs

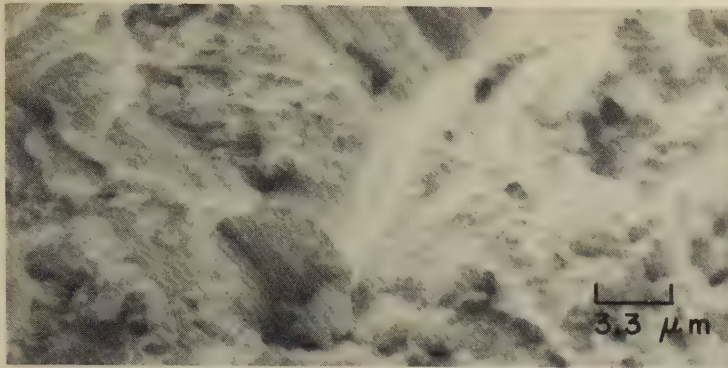
3651 Fracture surface in a specimen of the same steel, heat treatment and hardness as 3649 and 3650, but fractured by impact at 100 C (212 F). At this location, crack propagation was transverse to pearlite lamellae, which are plainly visible and could easily be mistaken for fatigue striations. See also 3652 (right).

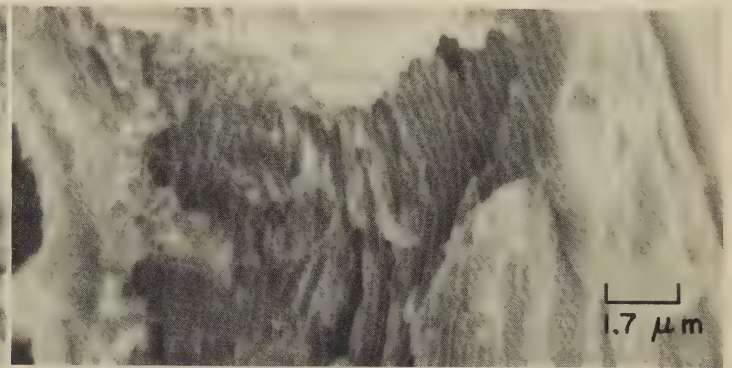
3652 Same as 3651 (at left), but showing a different region of the fracture surface at higher magnification. Note that in several local areas the pearlite lamellae have been separated by secondary cracks in a manner similar to, but less pronounced than, that shown in 3649.

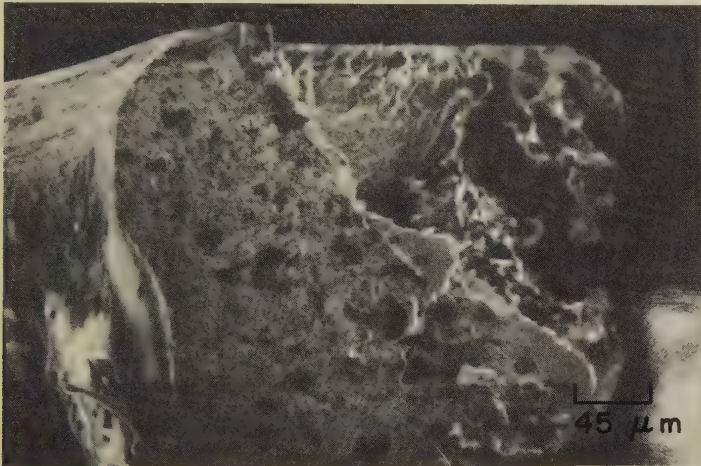
3653 1095 steel spring that fractured by fatigue in a card-tape-punch clutch assembly. The origin of the initial (fatigue) fracture is at lower left. The surface of the final abrupt fracture is at upper right. There appears to be evidence of smeared metal in the center of the fatigue-fracture surface.

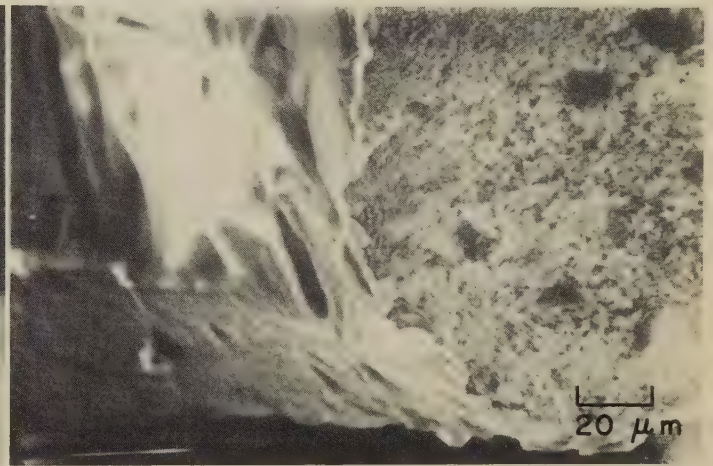
3654 Higher-magnification view of the fracture-origin area in 3653 (left). Just inside the fracture edge at bottom is a faint trace of features that bear a resemblance to fatigue striations. The adjacent outside surface of the spring appears to have undergone mechanical damage.

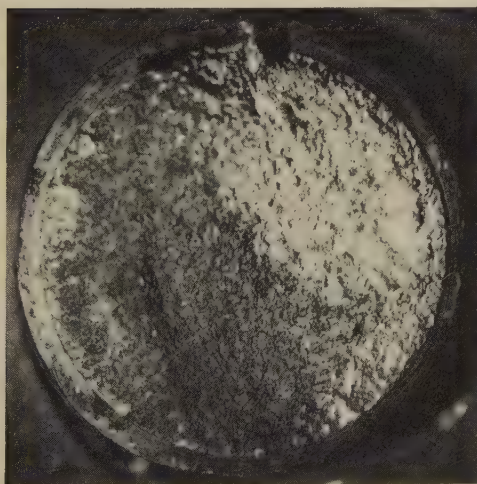
3655 Fracture surface of a broken clutch shaft of an air conditioner. Material is free-machining resulfurized 1115 steel. Note dark oxidized area. See also fractographs 3656 and 3657, at right.

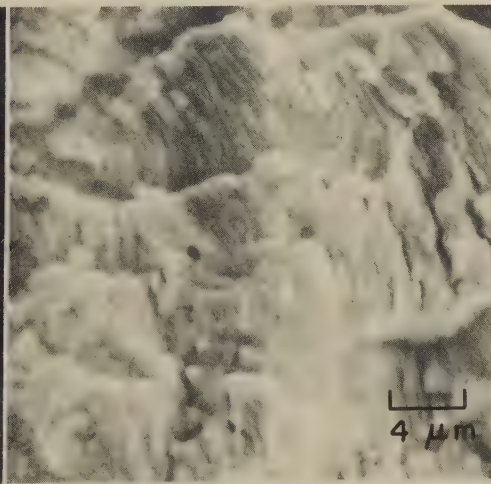
3656 SEM fractograph of region in oxidized area in 3655. Distinct striations indicate that initial cracking was by fatigue. Secondary fissures may be due to sulfide inclusions.

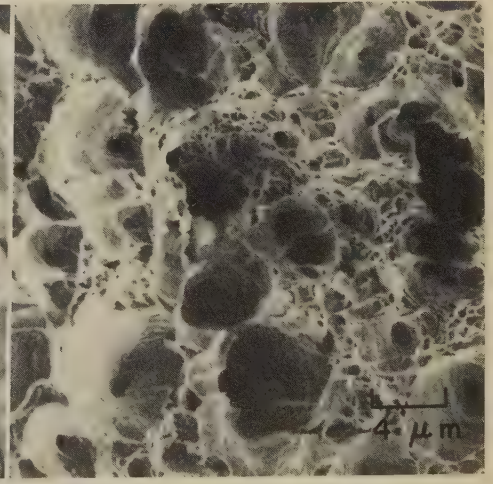
3657 SEM fractograph of a region in the bright area in 3655, showing variegated dimples, which indicate that final rupture was by ductile fast fracture. See also fractograph 3656, at left.

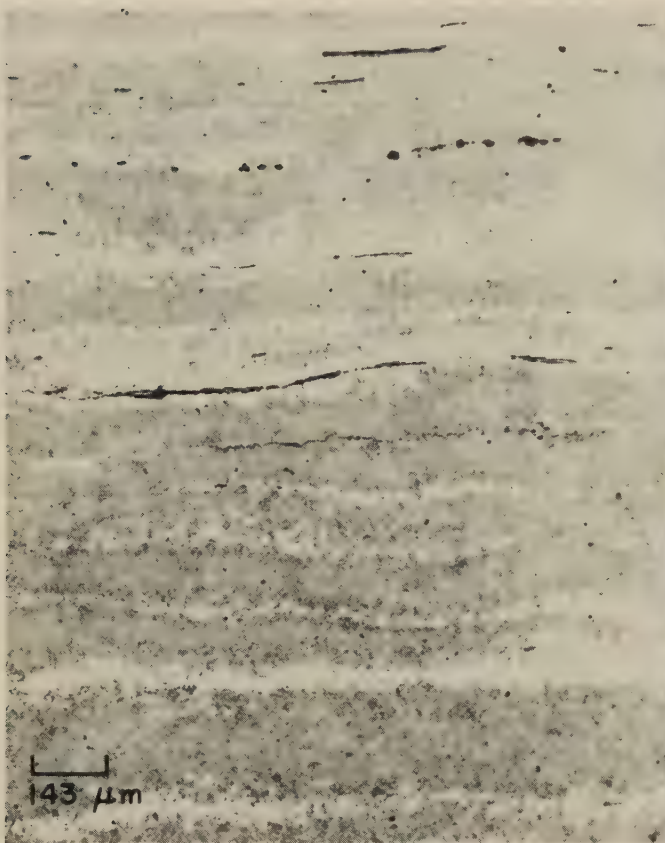
3658 Polished longitudinal section through a forged bar of 4070 steel that partially hardened in segregated regions during cooling from the normalizing temperature. Microstructure: dark bands consisting of pearlite and upper bainite; light bands consisting of martensite and retained austenite and containing black stringers of MnS. See 3659.

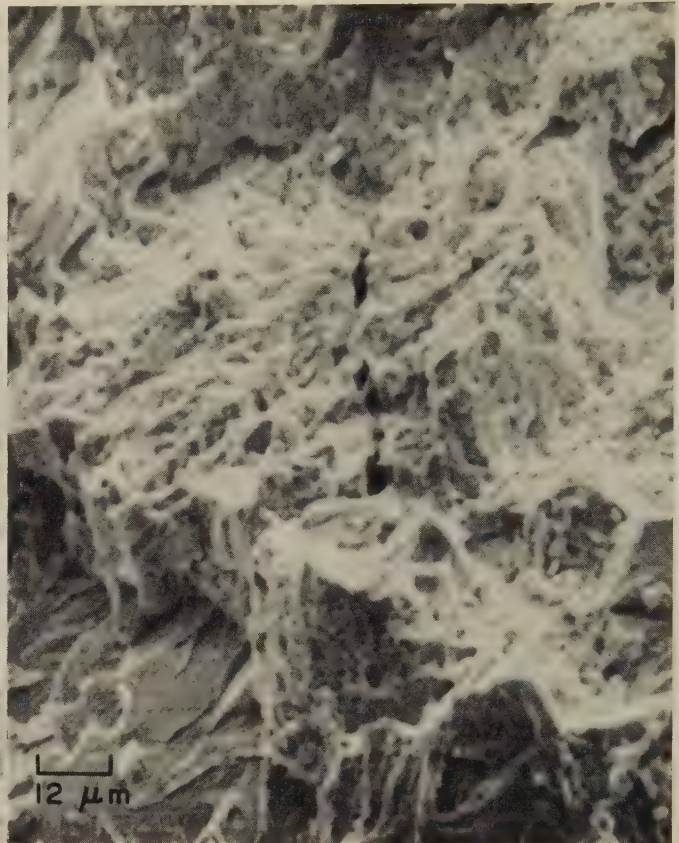
3659 Surface of a fracture in the bar shown sectioned in 3658. Fracture occurred both by cleavage and by microvoid coalescence. A longitudinal cleavage step extends diagonally across the area at lower left. This step and similar steps in the fracture surface could not be correlated with specific features of the banded microstructure in 3658.

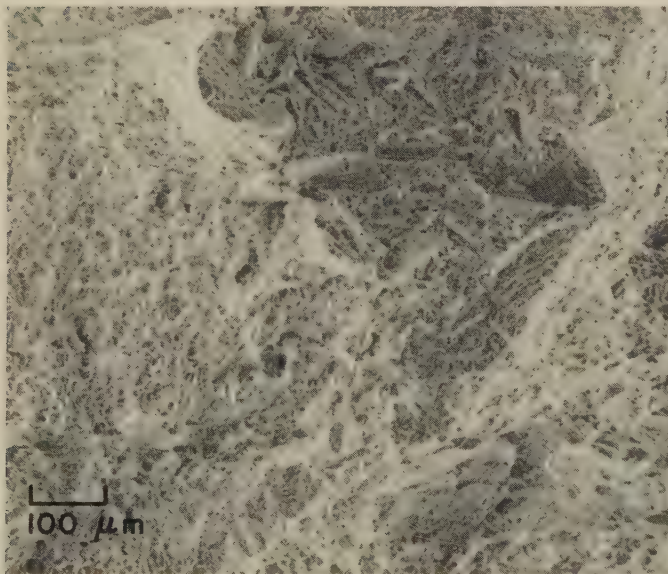
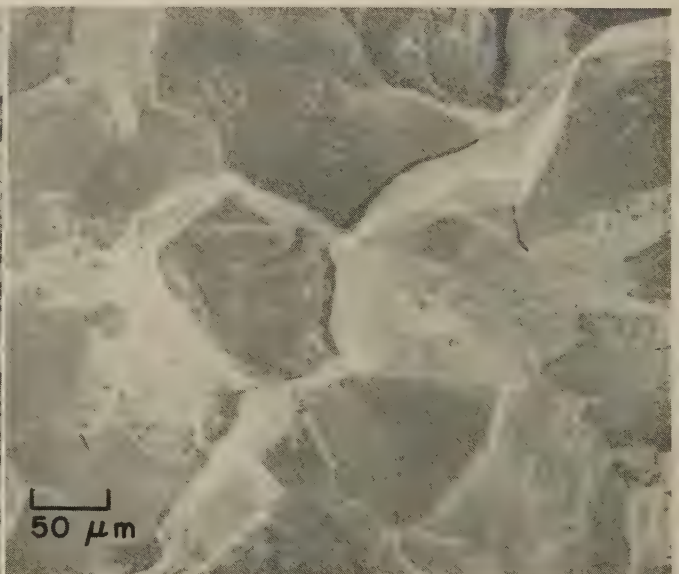
3660, 3661 Fracture surfaces of specimens of 4130 steel that were fractured in plane-strain fracture-toughness tests at room temperature. Both specimens were given experimental heat treatments aimed at increasing fracture toughness. The specimen shown in 3660 (left) was austenitized at 1204 C (2200 F) and quenched in iced brine; K_{Ic} was 100 ksi·in.^{1/2} (110 MPa·m^{1/2}). The surface shows relatively large dimples and a few quasicleavage facets. The specimen shown in 3661 (right) was given the same heat treatment as described for 3660, but was then tempered for 1 hr at 350 C (662 F); K_{Ic} was 68 ksi·in.^{1/2} (75 MPa·m^{1/2}). The surface shows facets of intergranular rupture and scattered areas of dimples. See 3662 to 3665 (facing page) for effects of other heat treatments on the fracture behavior of this steel.

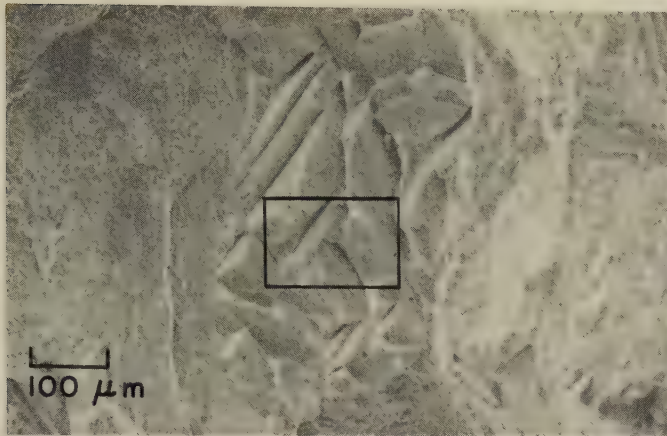
SEM fractograph 100×
3662 Fracture surface of a 4130 steel specimen given the same heat treatment as described for 3660, but oil quenched from the austenitizing temperature. The specimen was broken in a plane-strain fracture-toughness test at 22 C (72 F). Fracture shows pronounced angular cleavage in central region and finer cleavage details elsewhere. Rectangle marks area shown enlarged in 3663 (right).

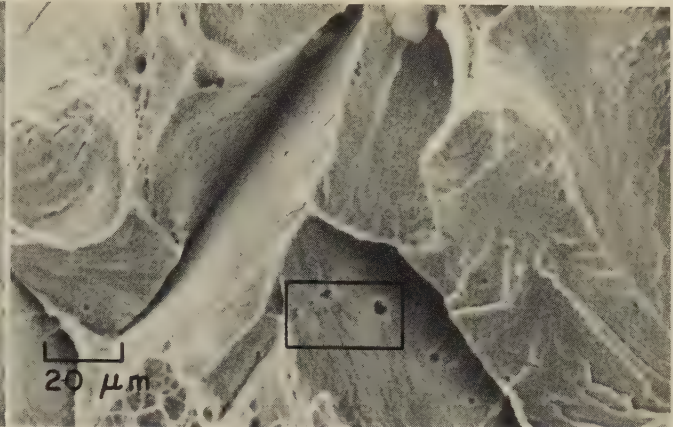
SEM fractograph 500×
3663 A higher-magnification view of the area within the rectangle at center in fractograph 3662 (at left), revealing more clearly the cleavage facets, which have radically different orientations. A few dimples can be seen at top left and at bottom left. The rectangle here indicates the area that is shown at an even greater magnification in fractograph 3664 (below, left).

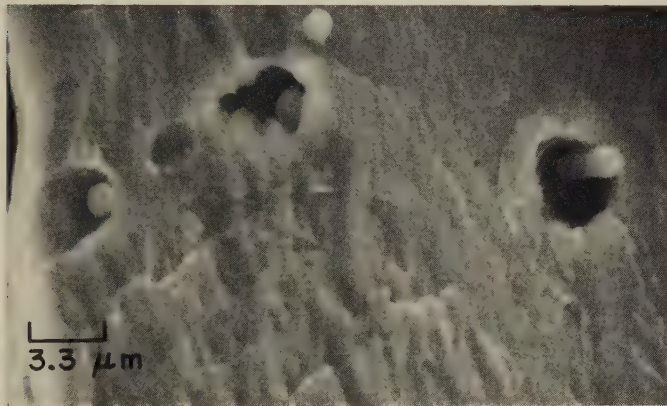
SEM fractograph 3000×
3664 A higher-magnification view of the area within the rectangle in fractograph 3663, showing a portion of one cleavage facet. Contained in the facet are several voids, each of which has opened around an inclusion. The marks on the facet do not suggest that these voids aided nucleation of the fracture.

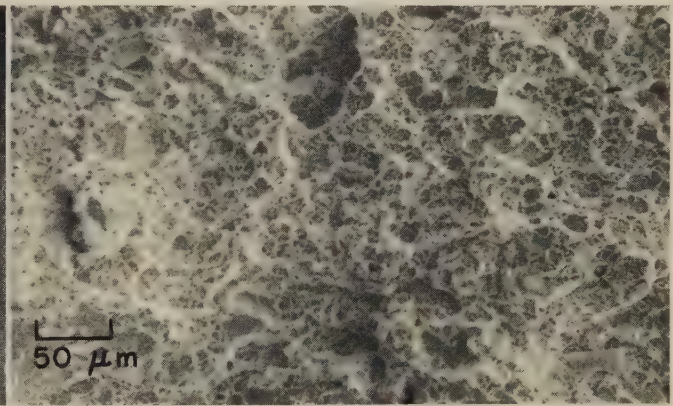
SEM fractograph 200×
3665 Fracture surface of 4130 steel specimen austenitized at 871 C (1600 F) and oil quenched (standard heat treatment). Broken in a plane-strain fracture-toughness test at 22 C (72 F). K_{Ic} was 55 ksi·in.^{1/2} (60 MPa·m^{1/2}), appreciably less than the fracture toughness of the specimen in 3660; however, the fracture surfaces of these specimens are very similar.

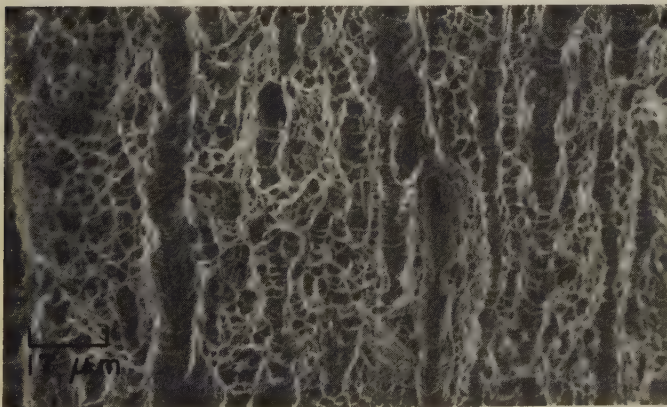
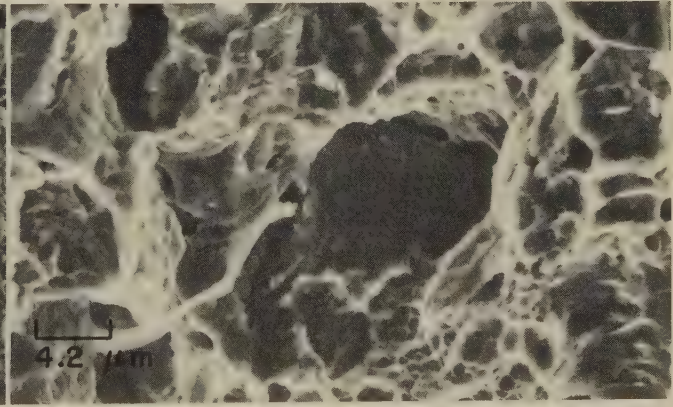
SEM fractograph 600×
3666, 3667 Two SEM views, at different magnifications, of the surface of a fracture in a specimen of 4130 steel that was austenitized at 843 C (1549 F), oil quenched, and tempered for 2 hr at 250 C (482 F). The fracture was produced in a toughness test in air; the rate of crack growth was in the range of rapid, unstable fracture. Dimples in an extremely wide variety of sizes, and channels formed by linear coalescence of voids, are evident. See also fractographs 3668 to 3673 for the fracture behavior of this material when tested in a hydrogen atmosphere.

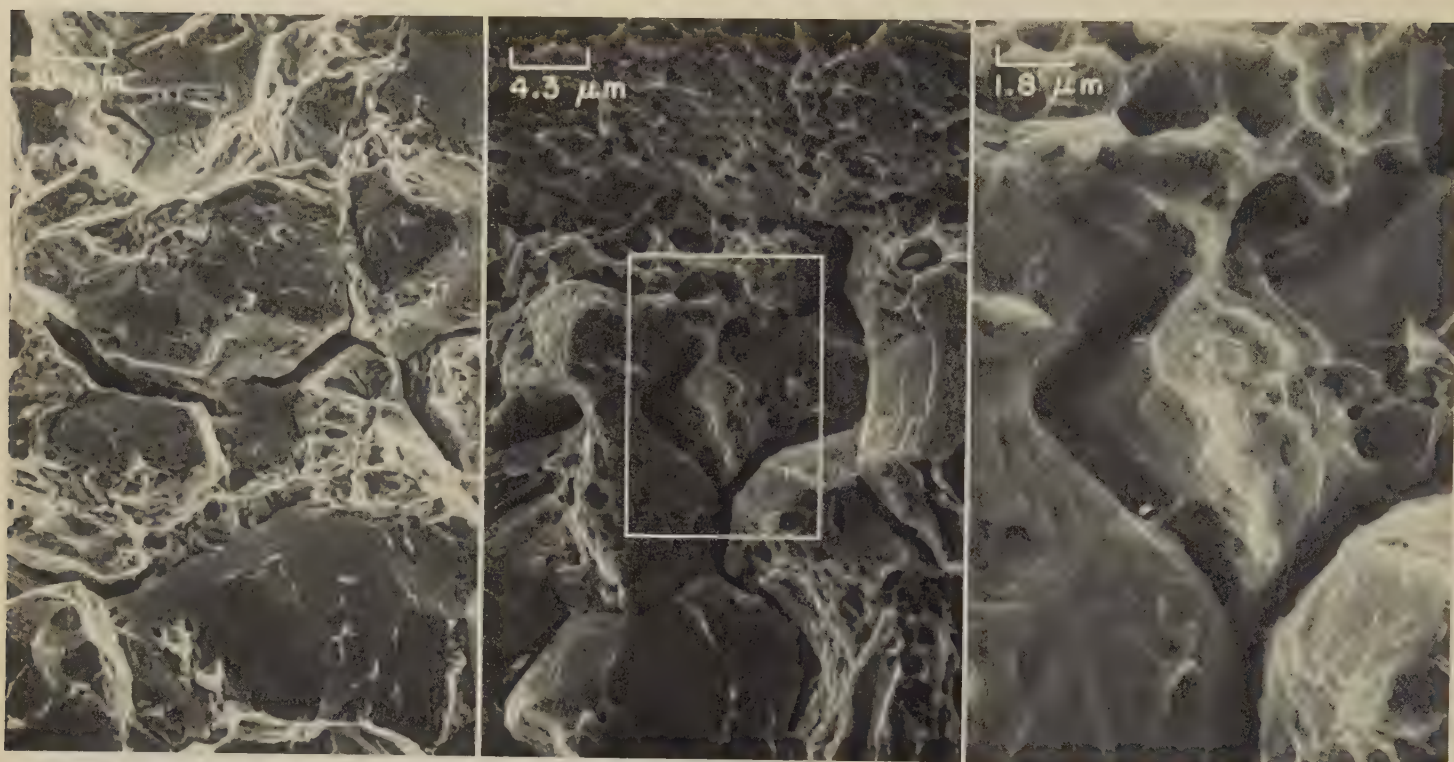
3668, 3669, 3670

Fracture surfaces of two specimens of 4130 steel that were given the same heat treatment as described in 3666 and 3667. The specimen shown in 3668 (left) was tested in one atmosphere of hydrogen at 24 C (75 F); the specimen shown in 3669 (center) and 3670 (right) was tested in one atmosphere of hydrogen at 80 C (176 F). Note that the area within the rectangle in 3669 is shown at higher magnification in 3670. In contrast to those in 3666 and 3667, these fracture surfaces show completely intergranular fractures with deep secondary cracks between the grains. The fracture in 3669 and 3670 also shows a considerable number of dimples that were formed by microvoid coalescence. See also 3671 to 3673 (below) for the fracture behavior of this material in an atmosphere of partially dissociated hydrogen.

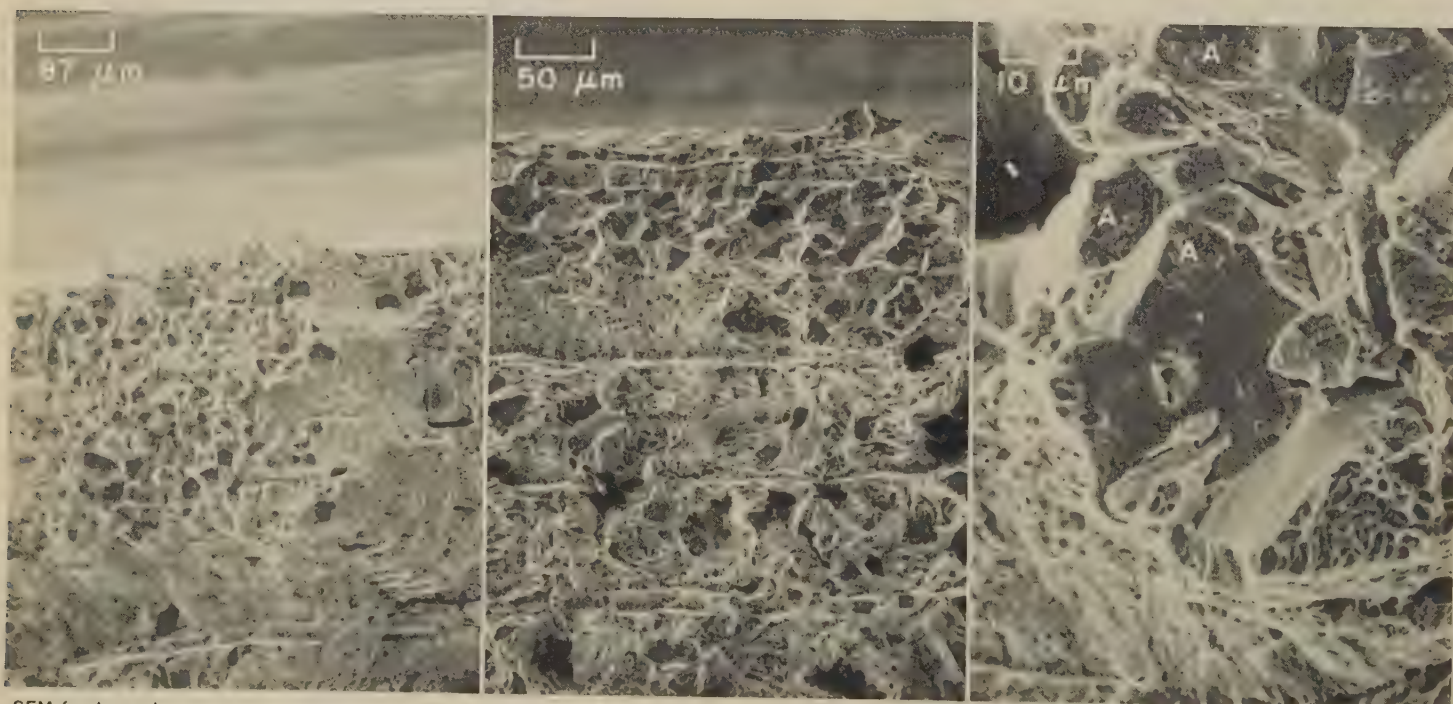
Three SEM views, at different magnifications, of the surface of a fracture in a specimen of the same steel and heat treatment as in 3666 to 3670, tested for stable crack-growth rate in 0.1 atmosphere of partially dissociated hydrogen at 80 C (176 F). Similar to the fracture in 3669 and 3670, this fracture shows facets of intergranular rupture intermingled with fracture surface parallel with the notch could be indications of temporary arrests of crack penetration. The horizontal marks in the A) visible in 3673 (right) are fine tear ridges typical of hydrogen embrittlement.

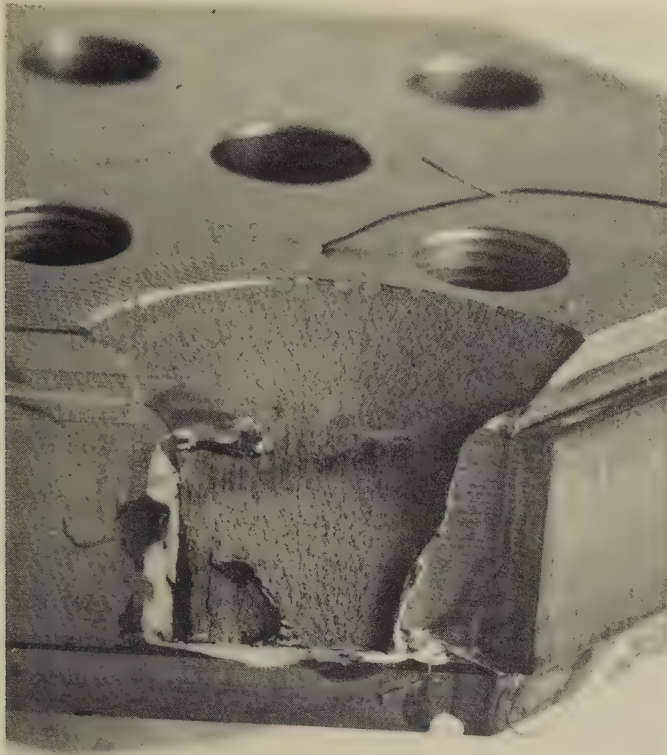
Light fractograph Actual size
3674 Fracture surface of a broken 4140 steel load cell. The radial marks indicate that two crack origins formed at the bottom surface of the cell, apparently near the toe of a weld. Note the continuous shear lip around the top edge. See also fractographs 3675 and 3676.

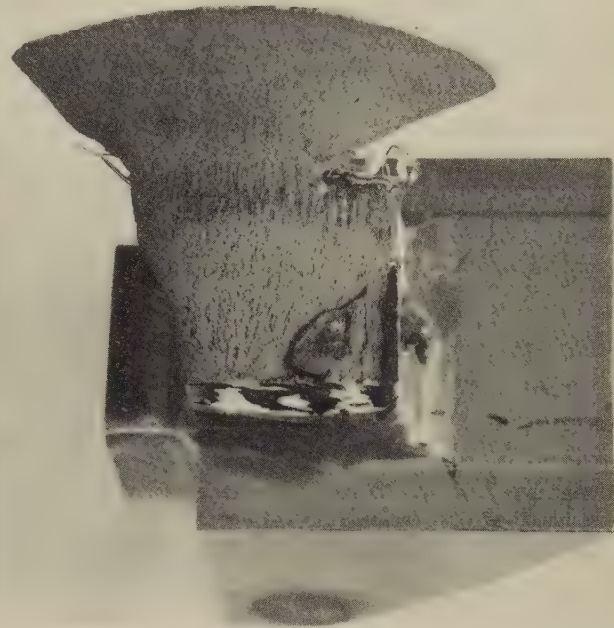
Light fractograph Actual size
3675 Mating fracture surface to that shown in 3674 (left). There appears to be no evidence of fatigue marks; however, fatigue cracking may have taken place within a very small area at the crack origins. Fracture was evidently caused by a sudden overload. See fractograph 3676.

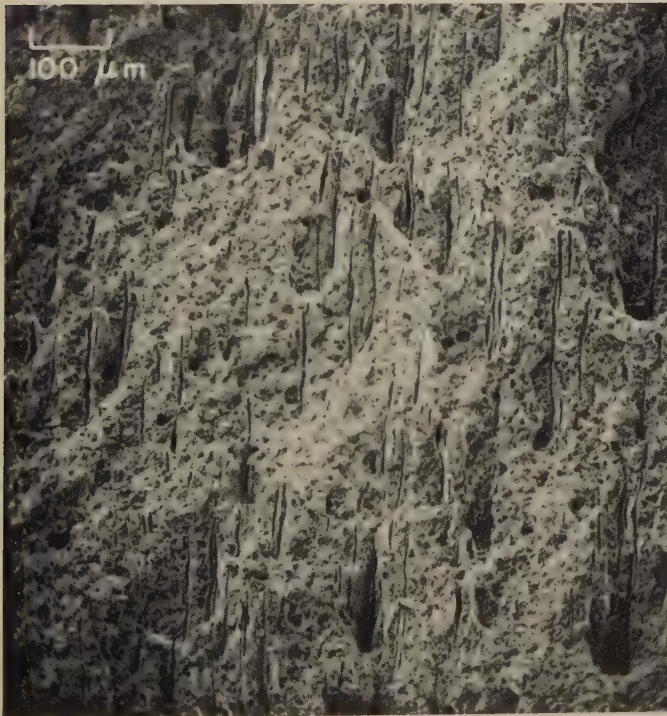
SEM fractograph 100×
3676 Magnified view of the fracture surface in 3674, taken at an area away from the edge, and showing the dimples that are typical of transgranular fast fracture. Vertical marks are sulfide stringers.

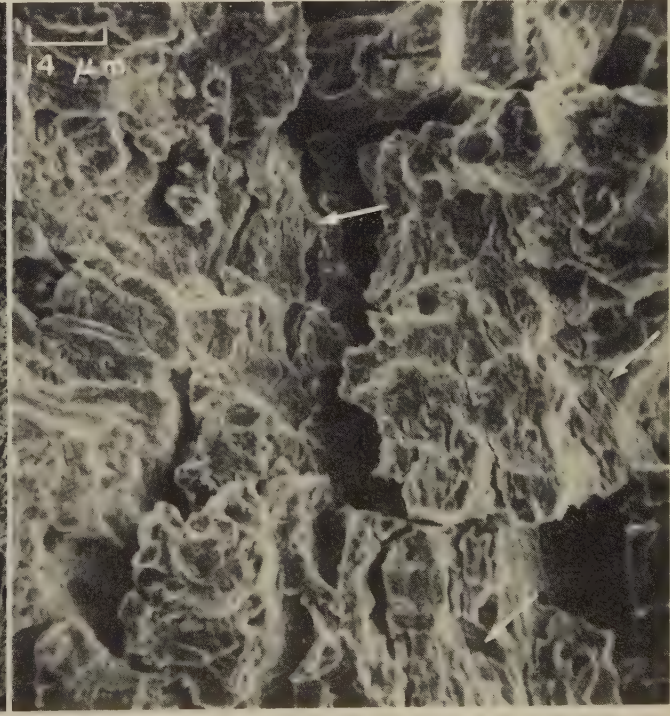
SEM fractograph 720×
3677 Fracture surface of a 4140 steel specimen that was heat treated to high strength and broken in fatigue. Deep secondary cracks are present. Features that appear to be fatigue striations (such as at arrows) may actually be fissures.

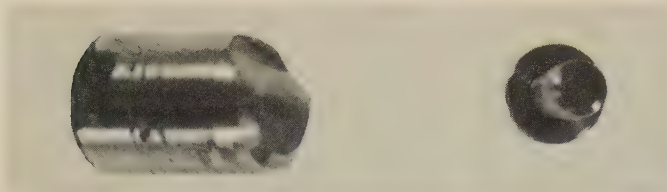
Photograph 1.75× Photograph 0.7×
3678, 3679 Views at different magnifications and at different orientations showing the mating halves of a fractured experimental connecting-rod bolt of 4340 steel that had been quenched and tempered to a hardness of Rockwell C 34 and that broke in a fatigue test. The crack origin is at the root of the thread that is visible at the bottom of the fracture surface at right in 3678 (left). See 3680-3685.

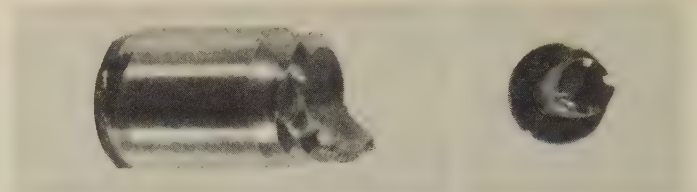
Photograph 1.75× Photograph 0.7×
3680, 3681 Views at different magnifications and at different orientations showing the mating halves of the second bolt from the experimental connecting rod described in 3678 and 3679, also of 4340 steel and quenched and tempered to a hardness of Rockwell C 34. Again, the crack origin is at the root of a thread, which is visible at the top of the fracture surface at right in 3680 (left). See also 3683 (below).

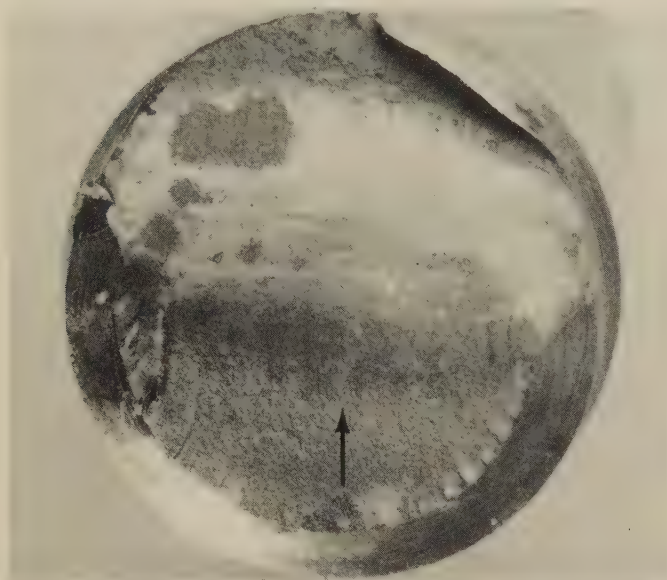
Light fractograph 7×
3682 End-on view, at higher magnification, of the fracture surface at right in 3678. A very smooth fatigue zone begins at several nuclei along the bottom and extends nearly through the entire section. Final, fast fracture produced the sharp shear lip at top. Arrow shows crack-growth direction.

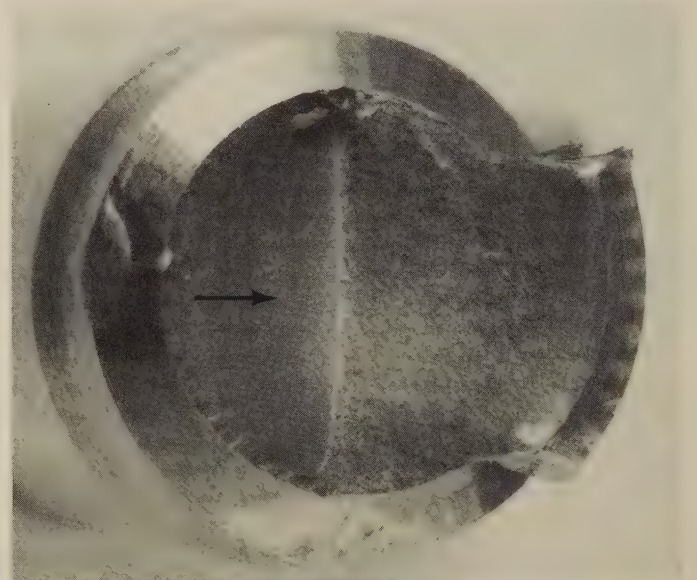
Light fractograph 7×
3683 End-on view, rotated 90° and enlarged, of fracture surface at right in 3680. There appear to be several crack origins in the thread root at left. The fatigue zone is unusually smooth and terminates at about midsection. Shear lip spans two threads. Arrow shows crack-growth direction.

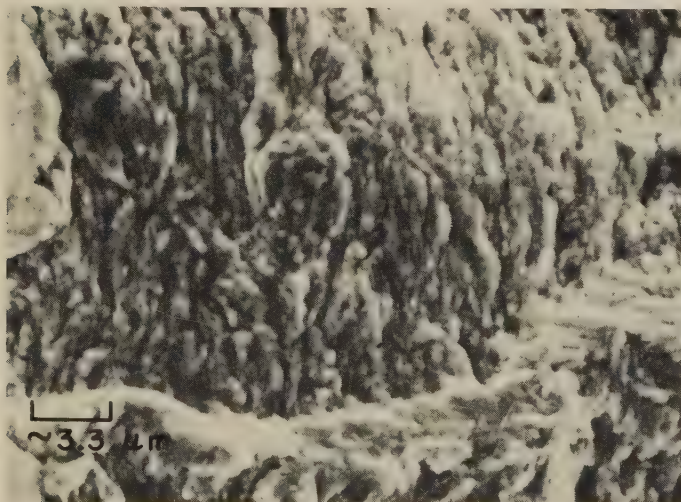
SEM fractograph About 3000×
3684 Higher-magnification view of the fracture surface shown in 3682, taken near the crack-initiation area. The dark features are believed to be striations. Some of them appear to have fissures associated with them. See also 3685.

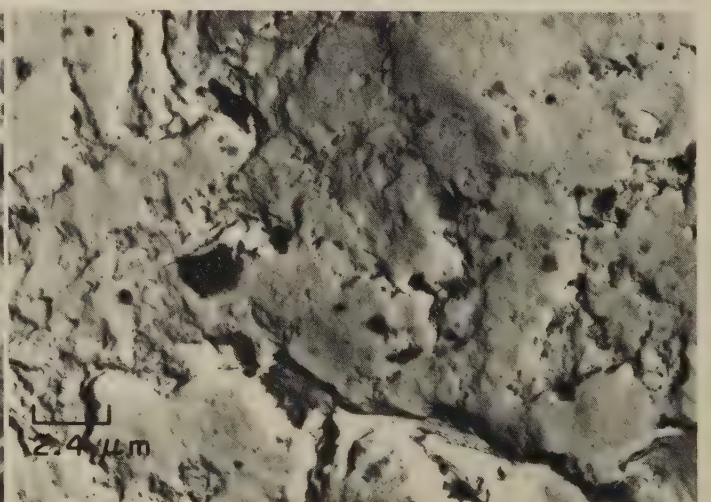
TEM fractograph 4100×
3685 Plastic-carbon replica of the fracture surface in 3682, but showing a different area than that in 3684 (left). Surface is essentially featureless, indicating a region of smeared metal that formed after the crack front had passed by.

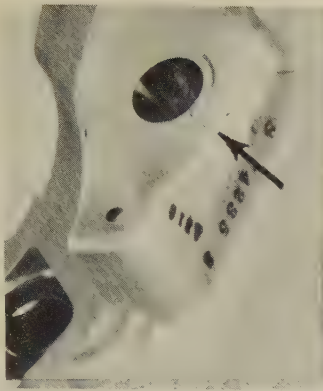
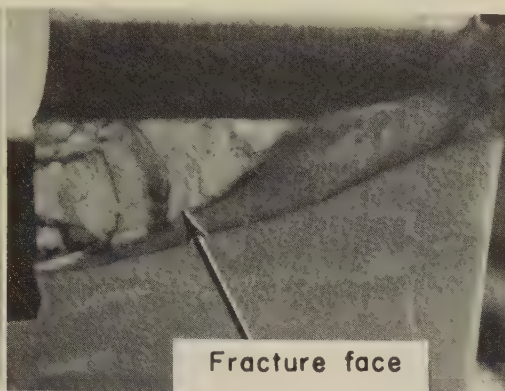
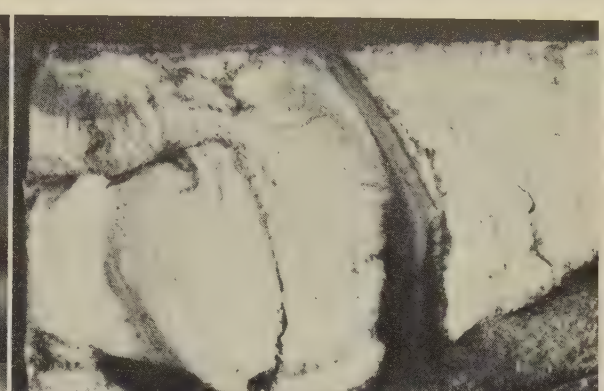
Photograph $\frac{1}{2}\times$
3686, 3687, 3688

4340 steel actuator arm from an aircraft maneuvering-flap assembly, which had been subjected to a fatigue test. In 3686 (left), which is a photograph of a portion of the actuator arm, a small crack is visible in the right side of the bearing hole (at arrow). Fractograph 3687 (center) shows a section through the cracked actuator arm in 3686, which was cut and then broken along the crack to expose the fracture surface. The bearing hole (at top) had been chromium plated, and then the entire actuator arm had been cadmium plated all over. Fractograph 3688 (right) shows a higher-magnification view of the fracture surface in 3687, and reveals the presence of a precrack at the site of nucleation of the main (fatigue) fracture (upper left corner). Fatigue striations were found in the area of nucleation. The chromium layer is visible at top right. See also 3689 to 3693 (below).

Three SEM fractographs that reveal the nature of the chromium plating in the bearing hole in the actuator arm shown in 3686 to 3688. Fractograph 3689 (left) is an oblique view showing the fracture surface (dark) and the plated surface of the bearing hole (light). Numerous parallel cracks in the chromium plating, parallel with the fracture surface, are clearly revealed. Fractograph 3690 (center), a view normal to the plated surface of the bearing hole, shows at higher magnification the network of cracks visible in 3689. The wear pattern on the plated surface is evident. Fractograph 3691 (right) shows, at still higher magnification, the edge of the fracture surface shown in 3689. Deformation of the hole has caused steps in the chromium plating. See 3692-3693.

3692 Section through the 4340 steel actuator arm shown in 3686, normal to the axis of the cracked bearing hole. The white layer at top is the chromium plating on the bare surface of the hole; note the closely spaced cracks, and the steps formed by deformation of the hole, which tilted the plate segments created by the cracks. See also 3693 (right).

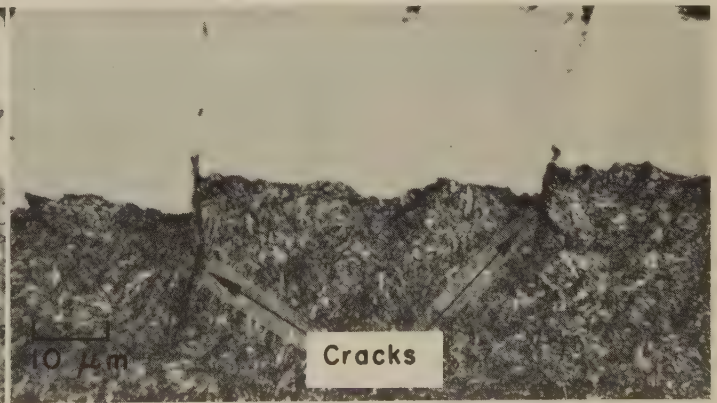
3693 Portion of micrograph 3692, shown at higher magnification to reveal more clearly that the cracks, which began in the chromium plating, penetrate the steel substrate as well. The hardness of the chromium layer is Rockwell C 62, and the hardness of the 4340 steel is Rockwell C 42; a heavy load was needed, therefore, to propagate the cracks into the steel substrate.

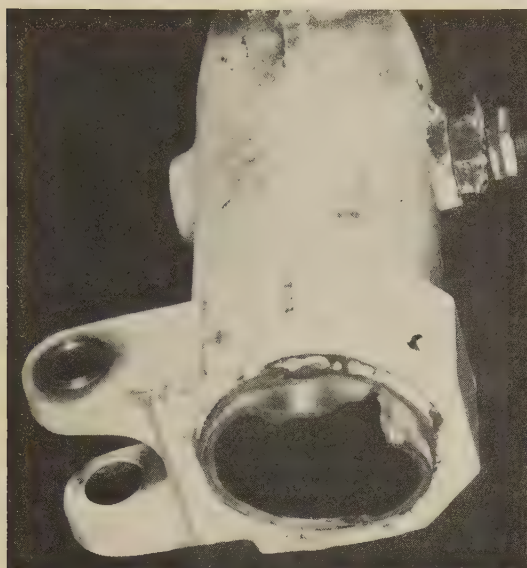
Photograph 3694 4340 steel tube (protruding from the socket of an aircraft landing-gear piston assembly) that cracked during heat treatment and that fractured in fatigue. The tube (2¼-in. OD, ½-in. wall) had been fitted ¾ in. into the socket and furnace brazed to it. Hardness of the tube, Rockwell C 47 to 48 (Rockwell C 43 to 46 was specified). See also 3695 to 3699.

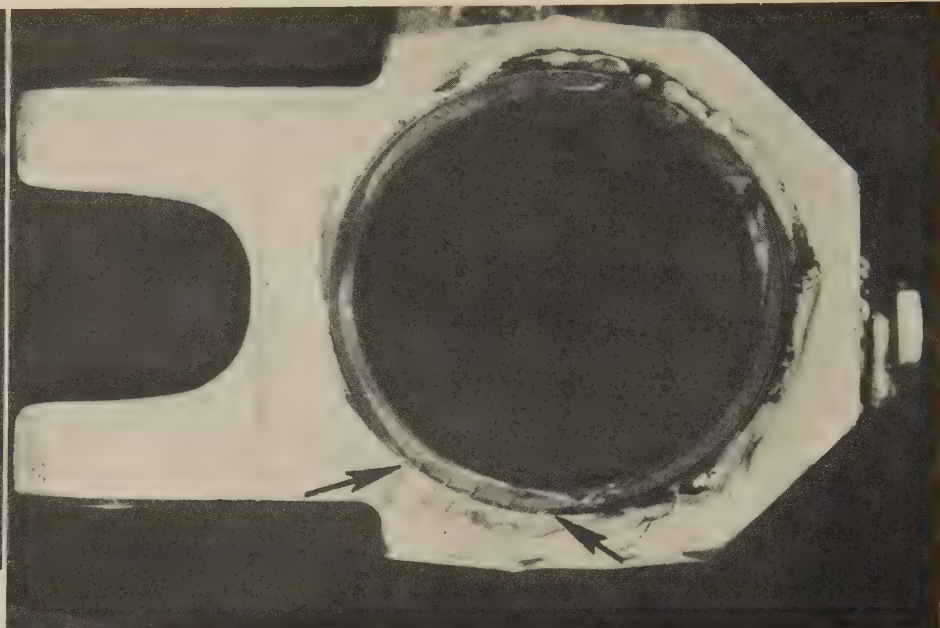
Light fractograph 3695 End-on view of the fractured tube shown in 3694 (at left), revealing a series of cracks at the outside surface at the point where the tube meets the socket. These cracks had merged to form a fracture (between the arrows at bottom) about ¾ in. long and approximately 0.05 in. deep at the point of initial penetration. See also fractograph 3696.

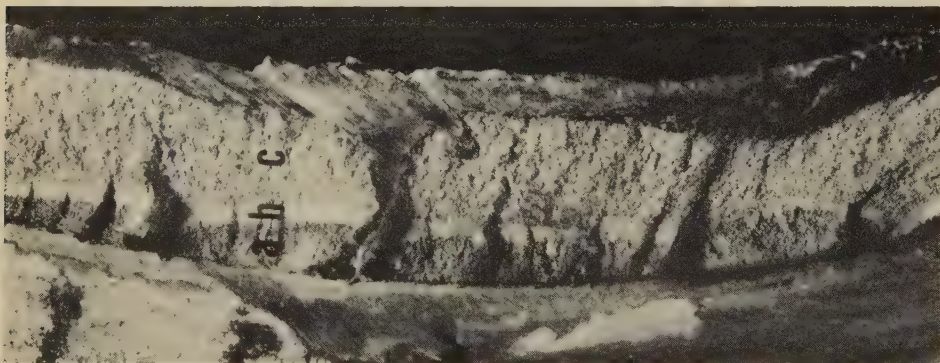
Light fractograph 3696 Higher-magnification view of the crack-origin region in 3695. At the outer (bottom) edge of the tube, the surface of the initial crack (a) is covered with a dark, high-temperature type of oxide evidently formed during heat treatment after brazing. Area (b) is a region of fatigue-crack growth. The remainder of the fracture surface (c) is the region of final, fast fracture. See 3697 to 3699.

SEM fractograph 3697 SEM fractograph of a portion of the oxidized region (a) of the fracture surface shown in 3696. The rupture is intergranular, and is attributed to cracking that occurred at high temperature.

SEM fractograph 3698 SEM fractograph taken near the edge of the region of fatigue-crack growth (b) in fractograph 3696, at the transition from intergranular (upper right) to transgranular fracture. Fatigue striations either are not visible at this stage of cracking or are hidden by debris.

SEM fractograph 3699 SEM fractograph that was taken in the region of final, fast fracture (c) in fractograph 3696. The features here suggest a transgranular mechanism of rupture, in part by microvoid coalescence and in part by quasicleavage.

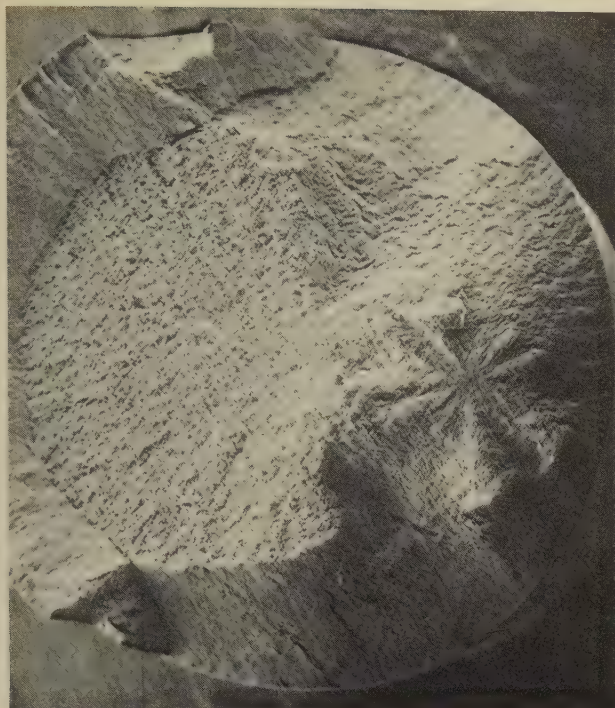
SEM fractograph 20×
3700 Surface of a fatigue fracture that occurred in tension-tension ($R = 0.1$) in a test bar of electroslag remelt 4340 steel heat treated to a hardness of Rockwell C 55. The origin of the fracture is an inclusion at the center of the "star" at right. See also fractographs 3701 to 3705, at right and below.

SEM fractograph 200×
3701 A higher-magnification view of the center of the "star" in 3700, showing the inclusion (dark, at center) that initiated the crack. Fine radial marks are evident. See fractograph 3702.

SEM fractograph 2000×
3704 Same fracture surface as in 3700, but a view from the region of fast fracture. Typical dimples, and local facets of quasi-cleavage. See also 3705.

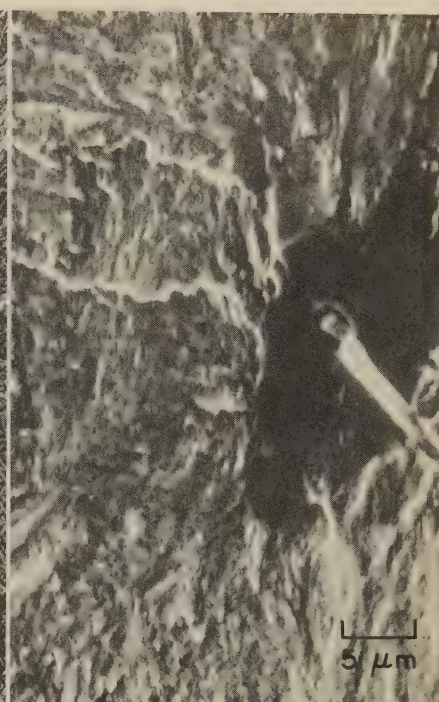
SEM fractograph 2000×
3702 Higher-magnification view of the inclusion (fracture origin) shown at center in 3701 (left). Little evidence of fatigue striations is found this close to the origin. See also fractograph 3703, at left below.

SEM fractograph 5000×
3703 View, at still higher magnification, of the inclusion in fractographs 3701 and 3702, showing that the inclusion was fractured by cleavage. The cleavage surface bears a bright metal sliver (at arrow).

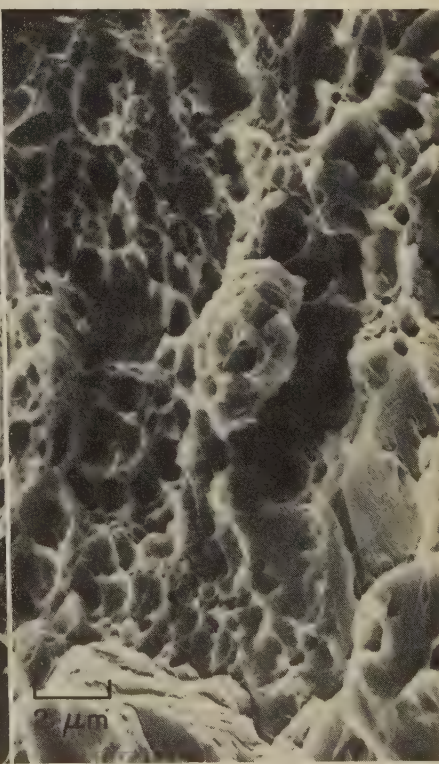
SEM fractograph 5000×
3705 Higher-magnification view of the area within the rectangle in fractograph 3704 (left), showing more distinctly that the dimples are present in a wide variety of sizes.

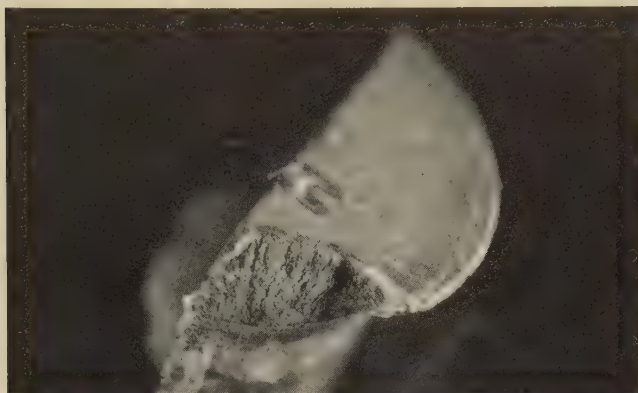
3706 Fractured head of a 4340 steel stud that had been hydrogen embrittled by electroplating without subsequent baking. The details of the fracture surface are shown, at successively higher magnifications, in 3707 (at right) and in 3708 and 3709 (below).

3707 Fracture surface of the broken stud head in 3706, showing the intergranular facets that are characteristic of hydrogen embrittlement. Voids (dark) suggest local dimpled rupture, but at this relatively low magnification a positive interpretation cannot be made. See 3708, a higher-magnification view of area in rectangle.

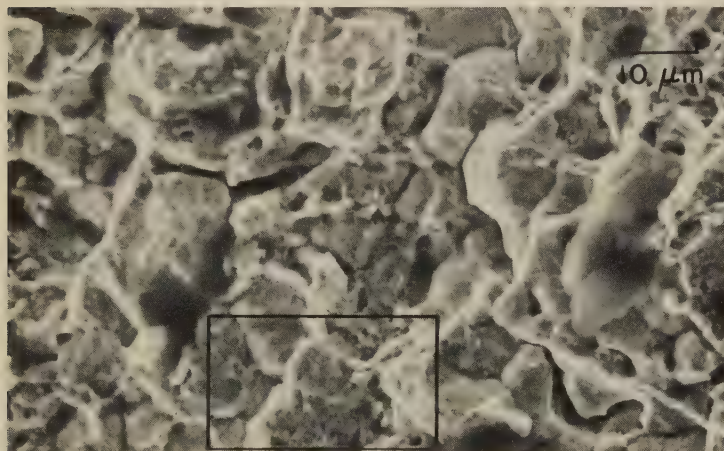
3708 Higher-magnification view of the area within the rectangle in fractograph 3707 (above, right). Both intergranular facets and secondary intergranular cracks are clearly visible. A few areas suggest microvoid coalescence. See also fractograph 3709 (right), which is a higher-magnification view of the area in the rectangle here.

3709 Higher-magnification view of the area within the rectangle in 3708 (at left). Intergranular facets containing extremely small dimples are visible at center and at top. Secondary intergranular cracks are clearly evident at left. Elsewhere, the mechanism of fracture is a mixture of microvoid coalescence and intergranular rupture.

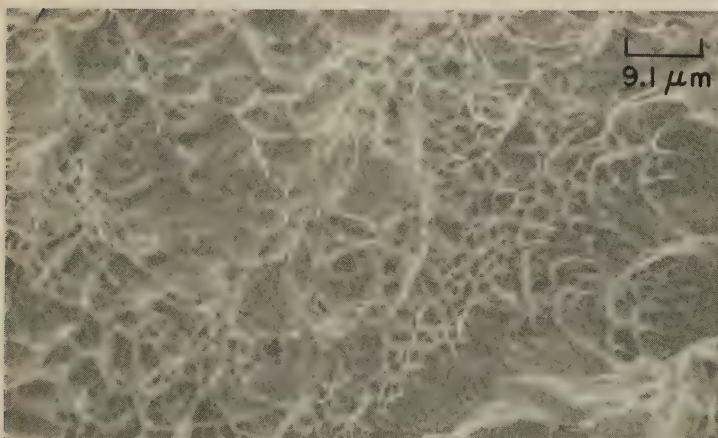
3710 Surface of a fracture in a specimen of HY-180 steel broken by mechanical tensile overload in air, showing dimples of rather uniform size with no indications of secondary cracking. Large level areas (such as those at left of and below center) suggest local stretching. See 3711.

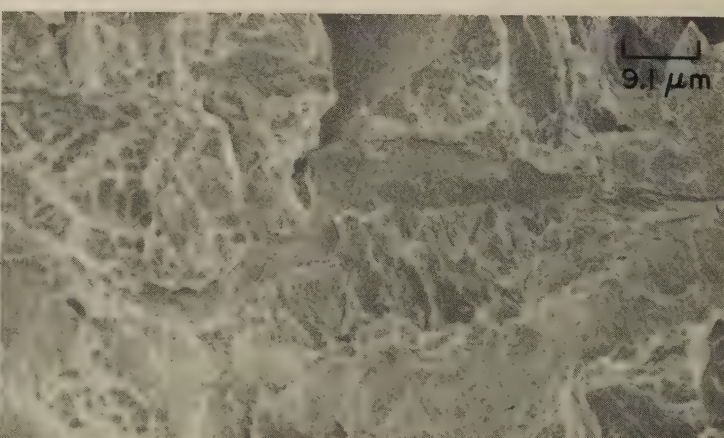
3711 Surface of a fracture in a specimen of HY-180 steel that broke under sustained tensile load in one atmosphere of hydrogen. The crack apparently was propagated by mixed mechanisms — dimpled rupture at left, intergranular rupture at upper left and at right, and quasicleavage at center.

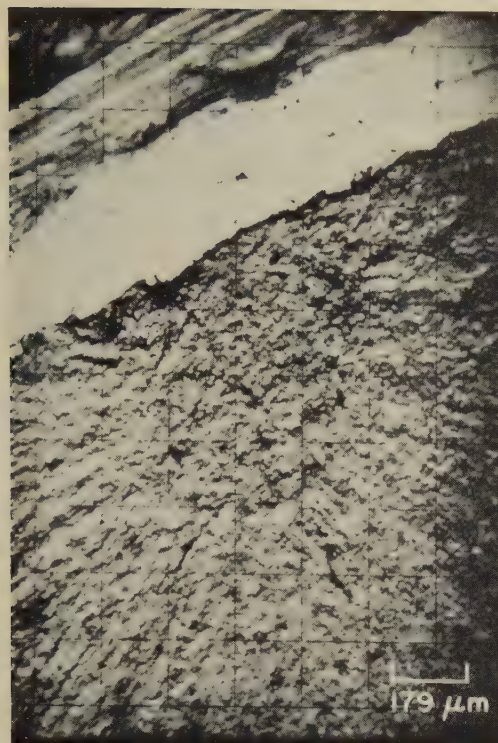
SEM fractograph 56×
3712 Surface of a fracture in an experimental high-strength steel stud that had been fired into a structure submerged in seawater, for anchorage during salvage. The fracture was initiated at a point beneath the surface of the stud. See also fractographs 3713 to 3717, at right and below.

SEM fractograph 176×
3713 Same as 3712, but at higher magnification. The surface had been machined away inadvertently, but not deeply enough to obscure the fracture origin and the marks that radiate from it. See 3714 for higher-magnification view of area in rectangle, which contains the origin.

SEM fractograph 17×
3716 Fracture surface of a companion stud to the one shown in 3712. This stud fractured by stress-corrosion cracking, thereby increasing the load on the stud shown in 3712 and contributing to its overload fracture. See also 3717.

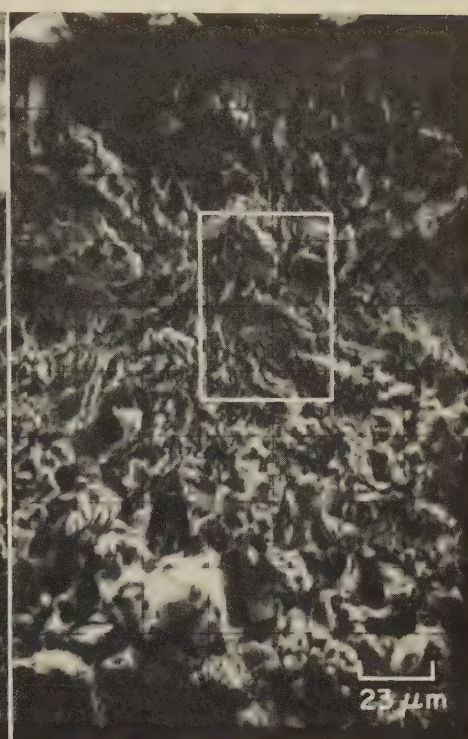
SEM fractograph 440×
3714 Higher-magnification view of the area in the rectangle in 3713. Fracture surface suggests mechanical overload failure, but is partly obscured by products of subsequent corrosion. See 3715 for a higher-magnification view of the fracture-origin area (in rectangle).

SEM fractograph 1760×
3715 Higher-magnification view of the area in the rectangle in 3714. This portion of the fracture surface shows quasi-cleavage facets mixed with dimples. The areas marked A are scraped asperities.

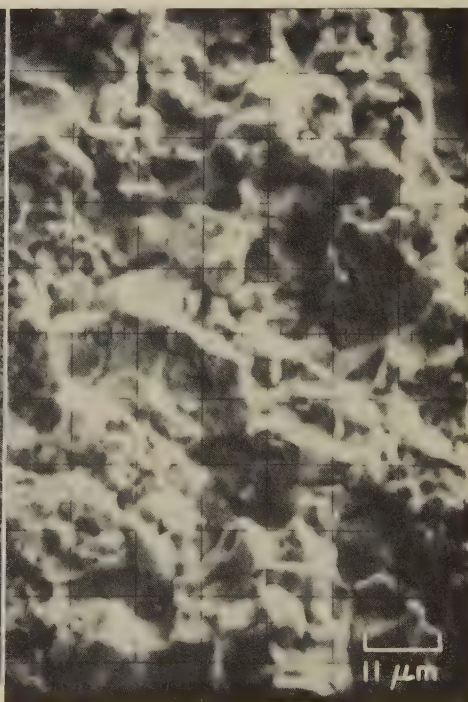
SEM fractograph 880×
3717 Higher-magnification view of the fracture surface in fractograph 3716 (at left), showing the intergranular characteristics that are typical of stress-corrosion cracking.

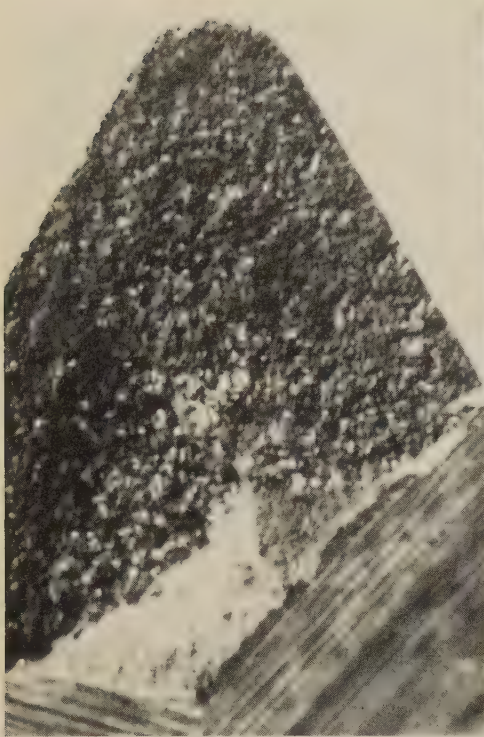
Light fractograph 23×
3718 Surface of intergranular stress-corrosion crack in a thread of a landing-gear bolt-torque link made of 300M steel. The crack was discovered in final inspection before service, and was exposed by sectioning and laboratory final fracture. See also 3719 to 3729.

SEM fractograph 1000×
3719 SEM view of a region of the outer edge of the fracture surface in 3718, showing the intergranular nature of the stress-corrosion crack. The part had been plated and stripped. See also fractograph 3720, a higher-magnification view of the area in the rectangle.

SEM fractograph 1000×
3721 Interior region of fracture surface in 3718, a short distance from edge in 3719, showing smaller amount of corrosion products than in 3719. Intergranular facets are interspersed with a few transgranular facets.
